# EVALUATION OF A COMPRESSION-LOADED-STITCHED-MULTI-BAY FUSELAGE PANEL WITH BARELY VISIBLE IMPACT DAMAGE\*

Donald J. Baker  
Vehicle Technology Directorate - ARL  
NASA Langley Research Center  
Hampton, Virginia 23681

Jian Li  
Structural Integrity Department  
The Boeing Company  
Mesa, Arizona 85215

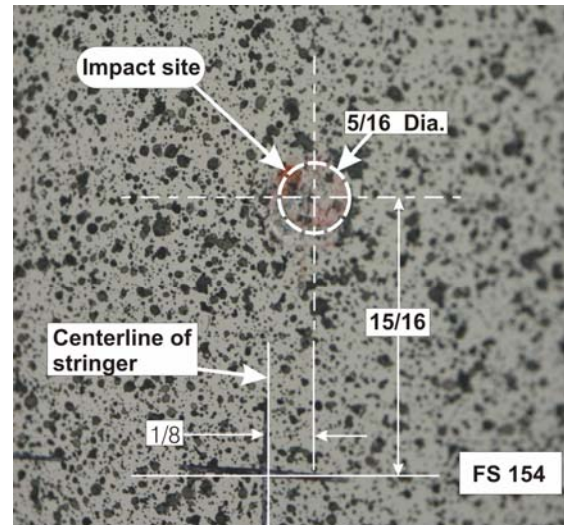
Figure 4 – Location of impact damage.  
(Dimensions in inches)

Panel *C-1* was placed under the impact tower shown in Figure 3 and a 5-lb weight with a 0.5-inch spherical radius impactor was dropped on the specimen. Lead shot bags was placed on and around the specimen to dampen the vibrations. The impact location was at the end of a center stringer termination adjacent to FS 154 on the Outer Mold Line (OML) side of the panel. The energy required to produce barely visible damage was determined on a different panel of the same design. The impactor was dropped 4-feet to give an energy level of 20 ft-lbs. Barely visible impact damage occurred on the specimen skin surface with the 20 ft-lbs of impact energy. A photograph of the impact site with the actual impact location is shown in Figure 4. The final impact site was 1/8-inch from the centerline of the panel. The profile of the contact force as determined from a load cell in series with the impactor is shown in Figure 5 and indicates a loss of stiffness as given by the contact force drop of approximately 150 lbs. after reaching the peak force of 908 lbs. The contact force recovered some but never exceeded the peak value of 908 lbs.

From the actual measurement and location of the impact damage shown in Figure 4, an accurate representation of the impact damage was created through local modeling that takes into account the damage size and location with respect to the center stringer centerline and distance from FS 154. A close-up of the finite element model of the impact site is shown in Figure 12. The nonlinear analysis used in reference 3 was modified to include the barely visible damage and was used to predict the panel response. Tie boundary condition was used to enforce displacement compatibility between the local model and the global model developed in Reference 3. The axial strain (y-direction) distribution at the OML ply predicted by the nonlinear analysis at  $P=1.63P_{cr}$  is shown in Figure 13. The results in Figure 13 demonstrate a global instability along FS 154 due to stringer web terminations. Also of interest is the fact that at the stringer termination location, the compression strain has a higher compression strain than anywhere else including the impact damage location. The predicted deformed shape of folding along FS 154 shown in Figure 13 compares well with the experimental observation shown in Figure 11.

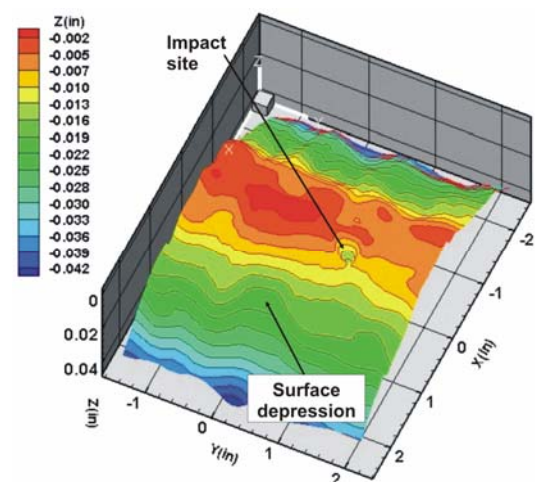
Figure 6 – Surface geometry after impact.

After impact and before any loading the profile of the impacted panel *C-1* was determined. The profile of the full panel did not show any significant changes due to the impact but results of the local area (3-inch by 4-inch) shown in Figure 6 indicates an impact dent depth of 0.008 to 0.010-inches deep. Deviations from the constant cross-section radius of 55.9-inches are shown in Figure 7 at a section through the impact site and at 2.0-inches from the impact site. This data indicates the dent is approximately 0.01-in. below the surrounding surface. This figure also indicated the cross-section radius is within 0.03-in. of the 55.9-in. radius.

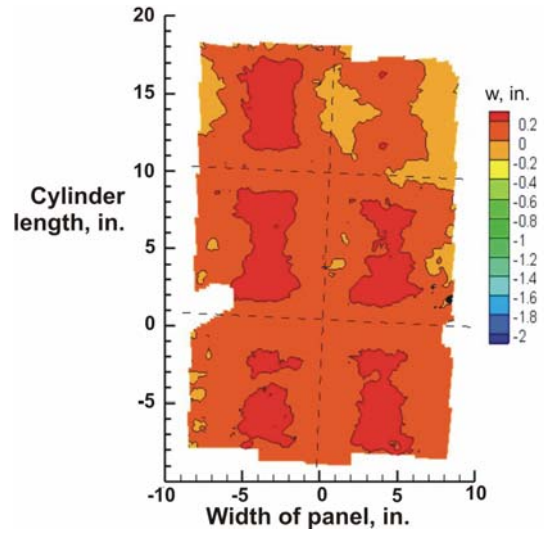
**Figure 8a – Out-of-plane displacements for  $N_y = 0.75P_{cr}$ .**

Displacements Panel *C-1* was loaded to failure at a low load rate of approximately 1,000 lbs. per minute. An obvious advantage of using the VIC-3D system is the full field recording of events at timed intervals through out the test. During loading, panel *C-1* had five of the bays that bowed out-of-plane in the positive direction (0.0 to over 0.01-inches) as shown in Figure 8a for  $N_y = 0.75P_{cr}$ . The upper R/H bay had out-of-plane displacements ranging from -0.01-inch to +0.01-inches as shown in the figure. The dashed lines superposed on the figures are the approximate locations of the frames and stringers. The positive displacement direction is away from the OML, or toward the viewer when looking at Figure 8a. Review of the image data for the

test to limit load indicated similar type of deformation patterns, except those images did not indicate an area of negative deformation between the two upper bays as shown in Figure 8a. It is possible that there was some damage under the stringer flange as the impact area was between the lower end of the stringer and the flange of the frame. Increasing the load to  $N_y = 0.96P_{cr}$  the same five bays still bowed in the positive direction while the upper R/H bay changed into three half-waves as shown in Figure 8b. Increasing the load to  $N_y = 1.006P_{cr}$  the upper R/H panel buckles as shown in Figure 8c. The only significant change in the other bays is the increase in size of the area of the positive out-of-plane displacement to over 0.02-inches. A second bay (middle L/H) buckled when the load was  $N_y = 1.075P_{cr}$  as shown in Figure 8d. The second buckle was not present at the load of  $N_y = 1.006P_{cr}$  although the presence of two positive displacement areas is noted. These areas could be the start of three half waves as seen in the upper R/H bay. The upper L/H and middle R/H bays increased in positive displacement as the load increases. The effect of loading was insignificant on the out-of-plane displacements of the lower two bays. This result was due to the fact that the lower skin was 40% thicker than the upper and middle bays (see Figure 1) and the outer two stringers on the lower two bays are twice the thickness of the other stringers. Increasing the load to 1.5 times the buckling load produces a deformation pattern as shown in Figure 8e. It appears that the deformation from the buckle in the upper R/H bay extends into the edge of the stringer. Increasing the load to  $N_y = 1.63P_{cr}$  produced the deformation pattern shown in Figure 8f. This is the last image before maximum load of  $N_y = 1.64P_{cr}$  is achieved. Note the major change between Figures 8e and 8f is in the upper L/H bay and the change in shape of the buckle in the upper R/H bay. The depth of the buckle in the upper R/H bays is increasing while the depth of the buckle in the middle L/H bay is decreasing. The change in shape of the deformations on the upper bays would indicate the center stiffener in the upper bay has lost some of its effectiveness. The contours of positive out-of-plane displacement shown in Figure 8f indicates the entire cross section is bending.

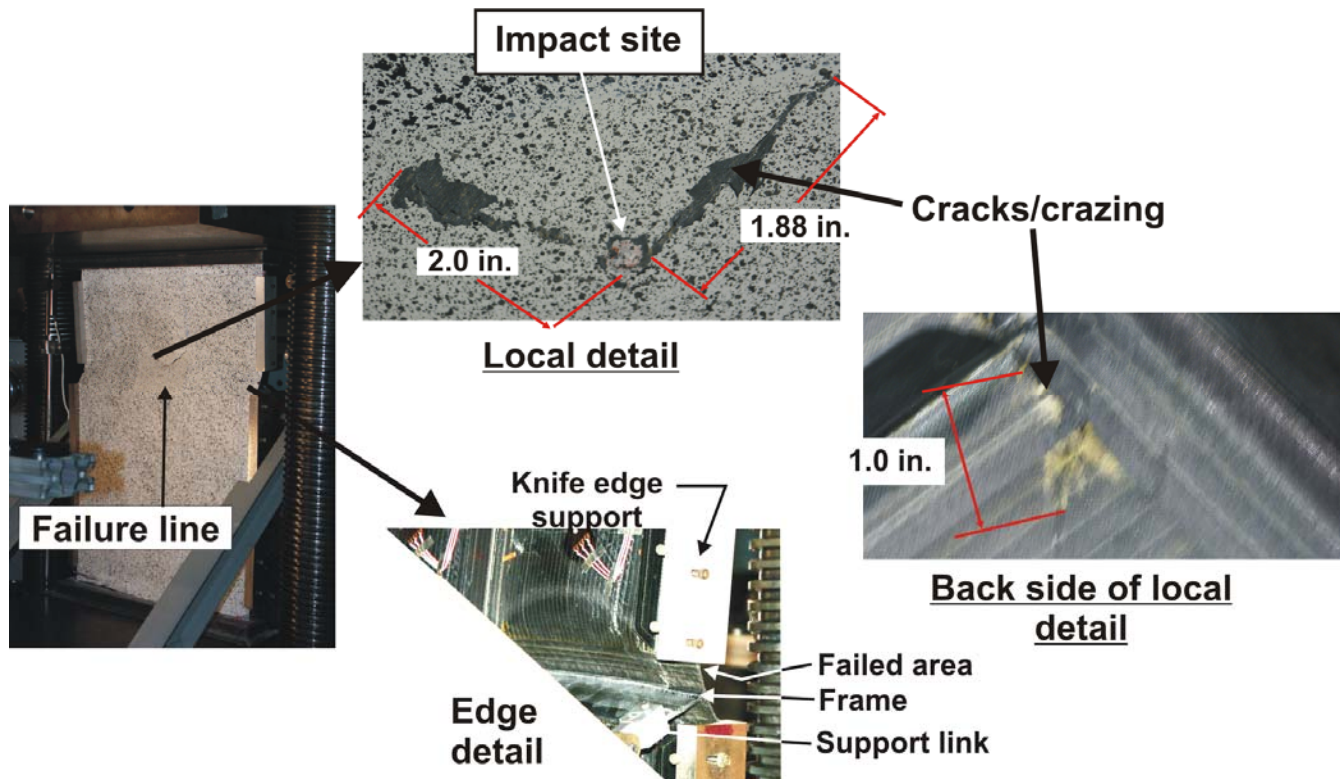
Figure 11 - Failed panel C-1.

Panel C-1 failed at  $N_y = 1.64P_{cr}$  and a photograph of the failed specimen in the test machine is shown in Figure 11. The panel failed by folding in the skin adjacent to the flange of frame at FS 154. The edge view detail shows the out-of-plane displacement. The impact site is in the failure line but did not appear to have any significant effect on the failure mode. Close up photographs of the area at the impact site indicate cracks/crazing radiating from the impact site.
